## Wakehurst Place Relay Station Archaeological Investigation Additional assessment by CART

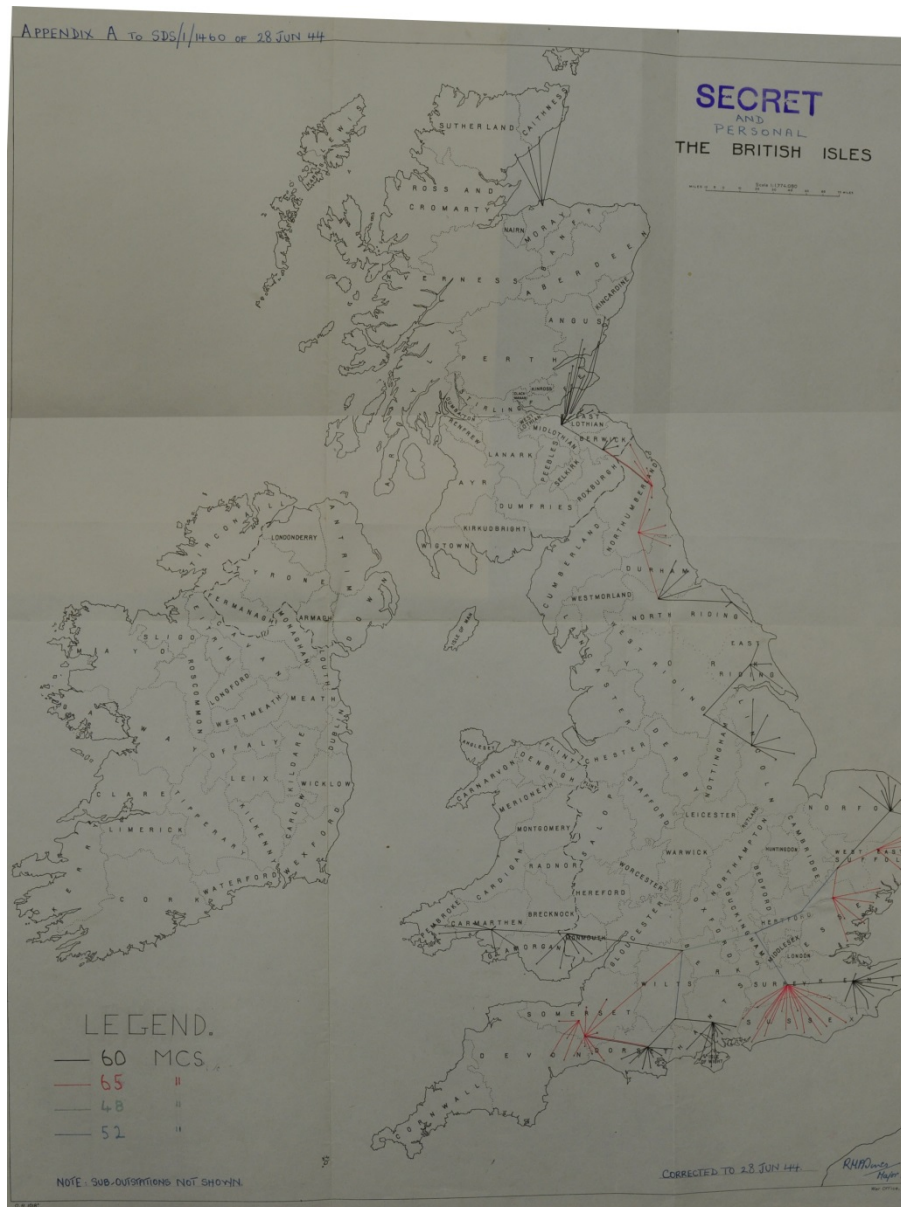
There are very few contemporary sources for the Auxiliary Units Special Duties branch which mention locations. One key source is known as the Major Jones map. This shows the approximate location of all the Special Duties stations on a map of the British Isles, with the links and frequencies used on the networks. It is signed by Major RMA Jones, then commanding the Royal Signal contingent of the Special Duties branch, on 28<sup>th</sup> June 1944. Of note, both the Wakehurst Place and Heathfield control stations are absent from the map, indicating that they were likely no longer in use.

**The “Jones map” from National Archives file WO 199/1194  
Image © aux\_unit\_sigs group**

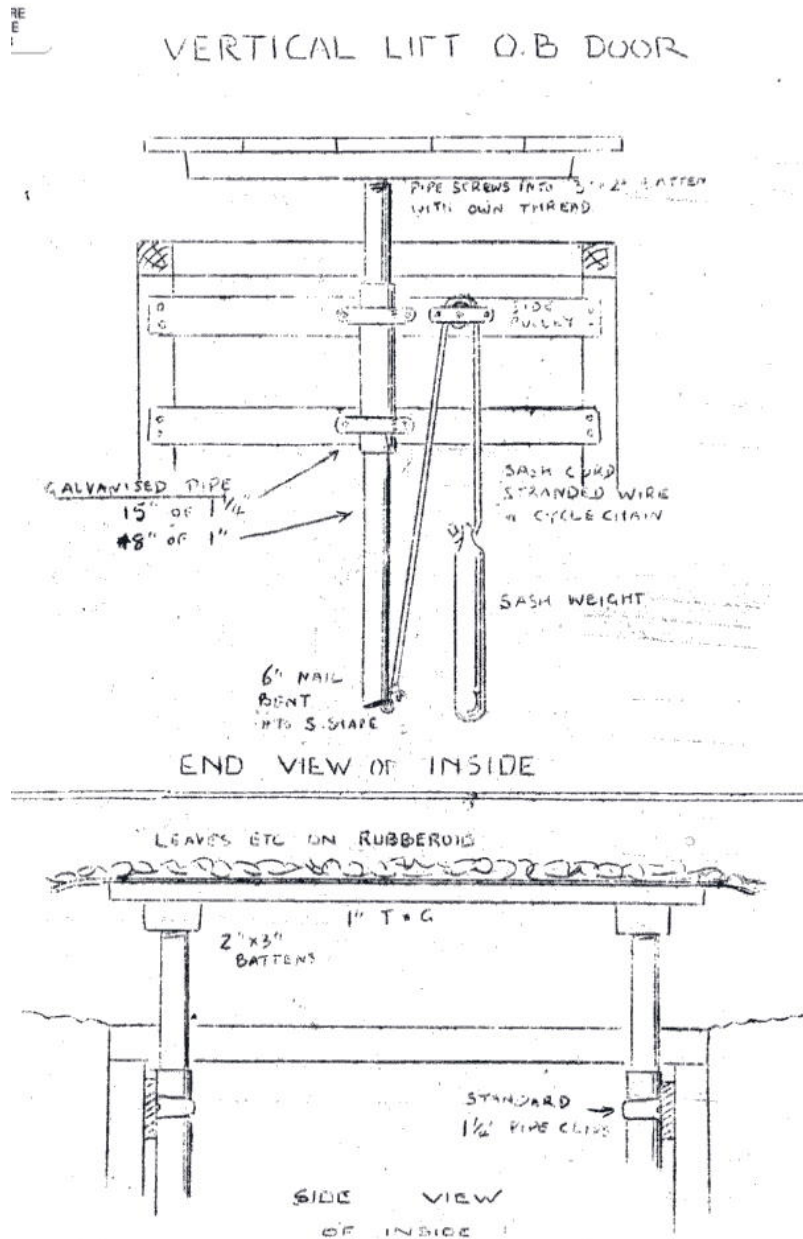
The only other primary source of relevance is a drawing produced as part of wartime training course at Coleshill House, which shows the construction technique for counterbalanced vertically raising hatch cover (Fig 1). The almost complete remains of similar mechanisms have been excavated at Coleshill House and Norwich, with parts of similar mechanisms on display at the British Resistance Organisation Museum at Parham in Suffolk. The important point is that the hatches were frequently not just simple hinged lids.

**Contemporary drawing of vertical lift mechanism with counterweights, provided as part of standard materials on training courses at Coleshill House.**

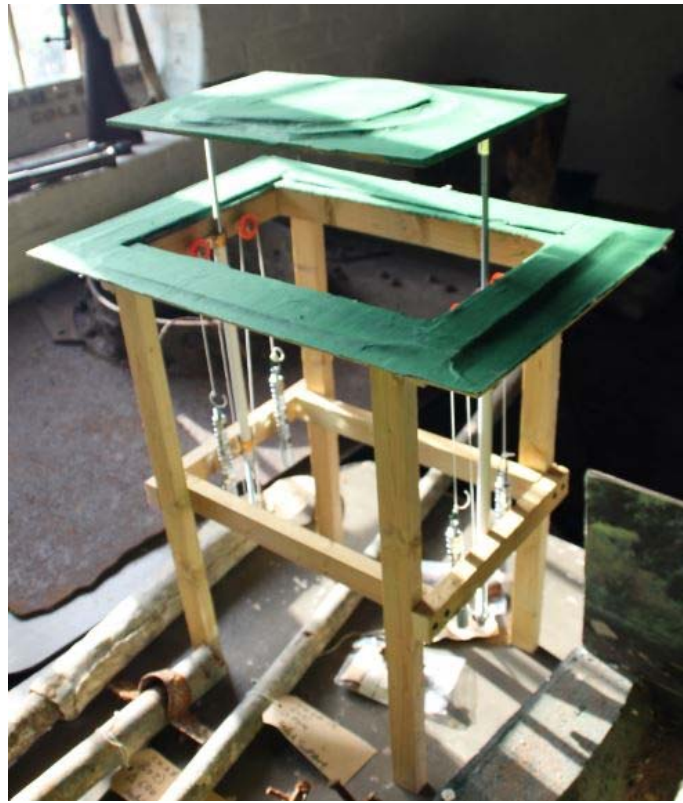
***A model example of the vertical rising counterweighted hatch mechanism. © CART.***
