**Preliminary Report on Jubilee Plantation Operational Base,  
Binnegar, Wareham, Dorset**

Dr William Ward  
Coleshill Auxiliary Research Team

May 2016

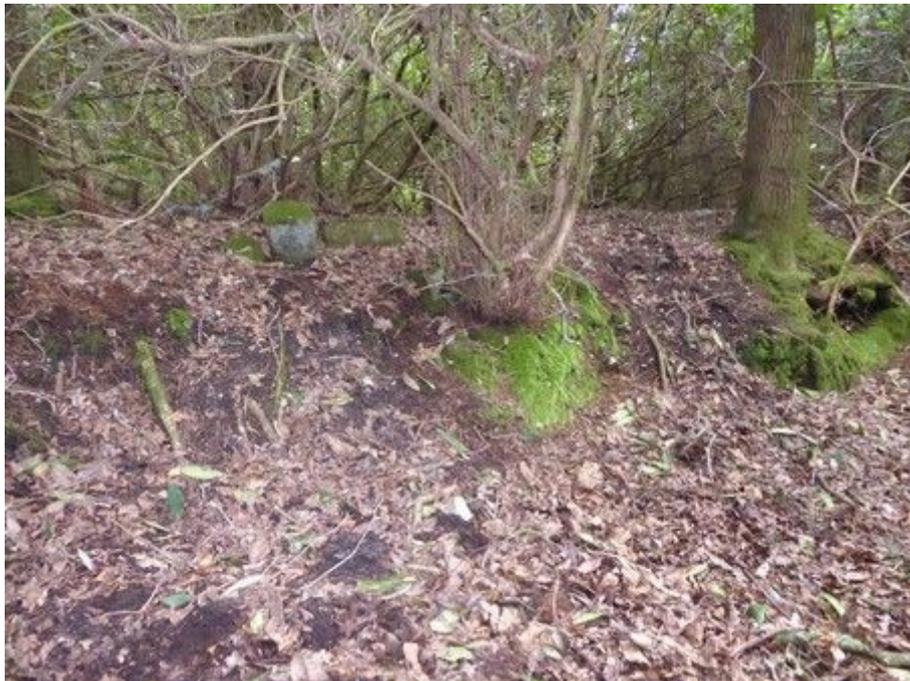
Photo 2: The main chamber is collapsed throughout its full length. At each end a breeze block wall remains, apparently largely intact. The chamber itself is an "elephant shelter", a corrugated iron curved roof structure, similar to a Nissen hut only using thicker iron sheet. The line of attachment of the roof can be seen on the end walls, although it has separated as a result of corrosion. Although the centre section cannot be seen, based on the survival of the visible end sections, it is likely that it survives in a corroded condition beneath the soil in the centre of the OB. The east end breeze block wall survives in good condition with a central doorway. A single glazed earthenware pipe can be seen set in the upper side of the southerly half of the wall. Two glazed earthenware pipes are set midway along the northerly bank of the collapsed main chamber just below ground level at an angle of approximately 60 degrees to its main axis.

Photo 2: View from within the main chamber area. To the left of the central tree are loose hollow concrete blocks. To the right can be seen the curved tops of two glazed earthenware pipes that formed part of the ventilation system.

The glazed pipes would have formed part of a ventilation system. There would have been a series of pipes at the base of the OB and others in the end walls and often centrally in the roof of the main chamber. Warm air would rise through the higher pipes, drawing fresh air in through the lower pipes. The pipes often ran a considerable distance from the OB with surface openings at the base of trees. The system was often extensive and complex with multiple pipes and sometimes condensation traps.

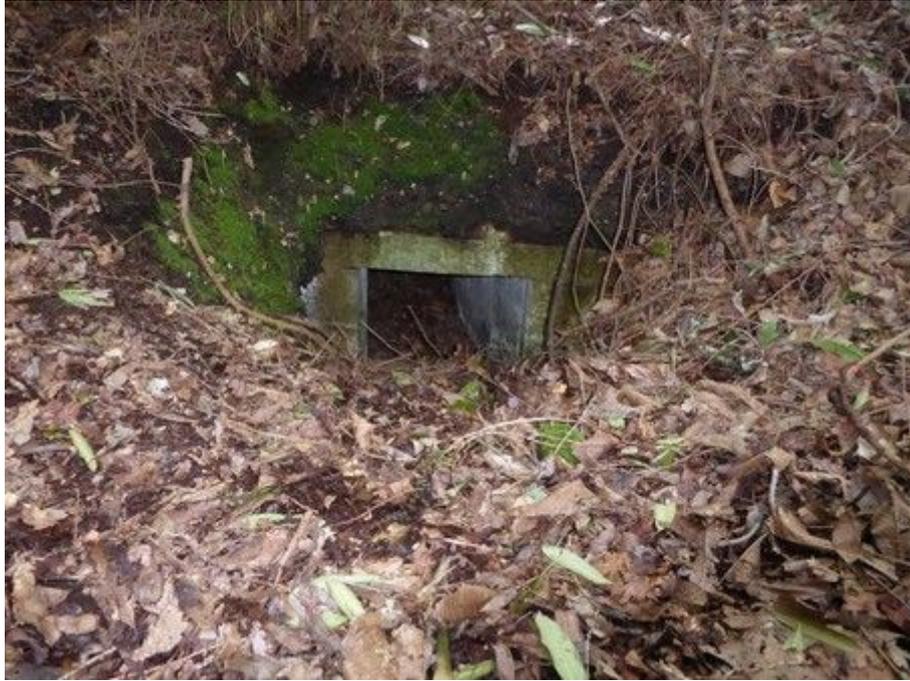
Photo 3: The doorway leads from the main chamber into a short tunnel, set at an angle to the alignment of the main chamber. This is also built from breeze blocks with a concrete roof and is approximately 0.9m (3 feet) wide and 1.8 m (6 feet long). The tunnel roof is at the height of the doorway and thus is lower than the main chamber roof height. This tunnel is filled with soil and leaf litter to within approximately 0.5m of the roof.

Photo 3: The diagonal tunnel seen from the main chamber

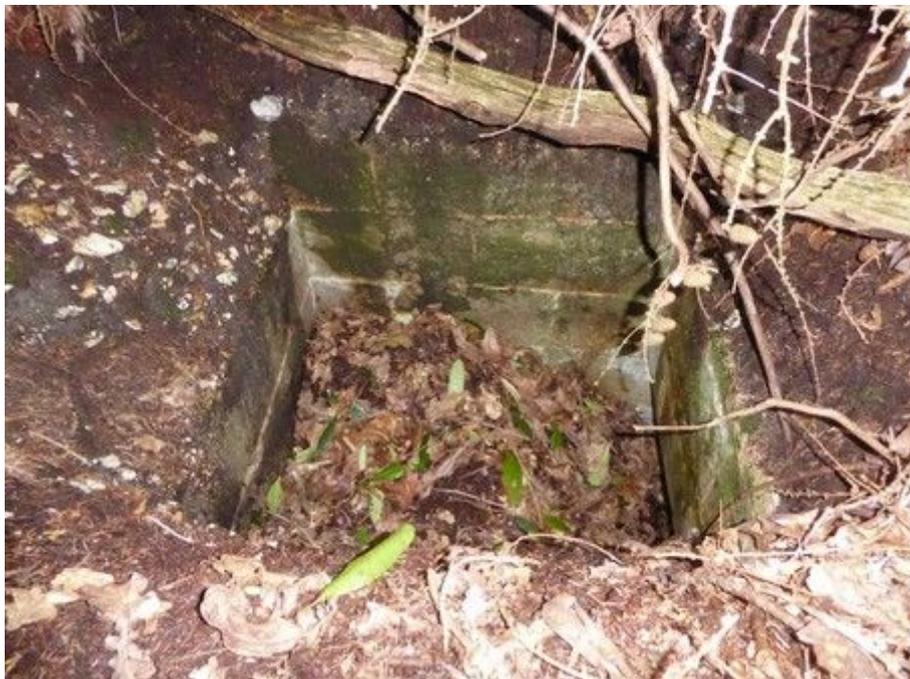
Photo 4: The tunnel leads into the easterly access shaft. This is also 0.9m (3 feet) square and built from hollow concrete breeze blocks. It is in better condition than the west shaft although the top row of blocks is largely missing. It is also partially filled with soil and leaf litter.

Photo 4: The westerly shaft with the tunnel entrance to the right

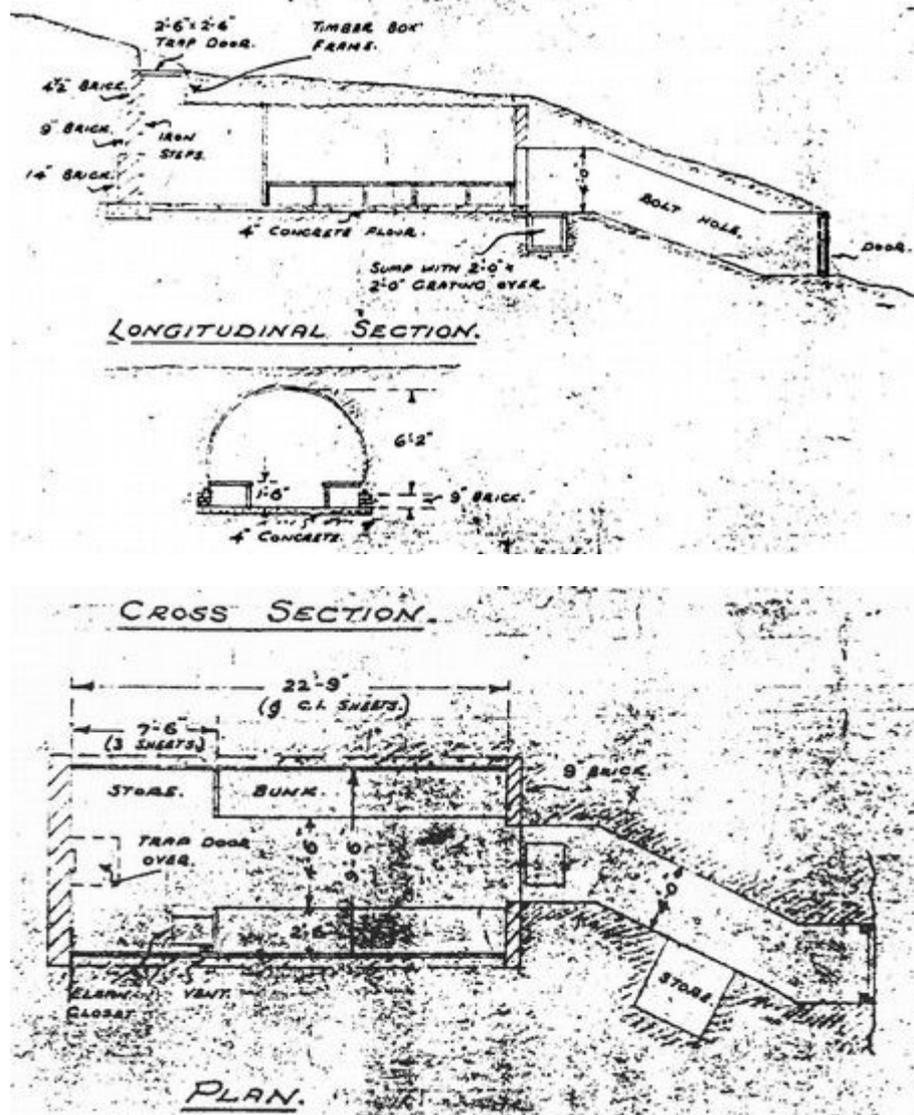
Figure 1: The standard plan for an OB provided to Royal Engineer Tunnelling Companies responsible for the construction of Aux Units OBs. (National Archives WO199/1915)

The structure largely follows the official design of an Auxiliary Units Operational Base (Figure 1). It has entrance and exit routes, a main corrugated iron chamber and a ventilation system using glazed pipes. The use of breeze blocks in the construction was not common early in the war, but became more common in Auxiliary Units structures built from late 1941. It is likely that the two shafts would have had camouflaged hatches and possibly some form of counter weighing system to help open a heavy hatch (Figure 2).

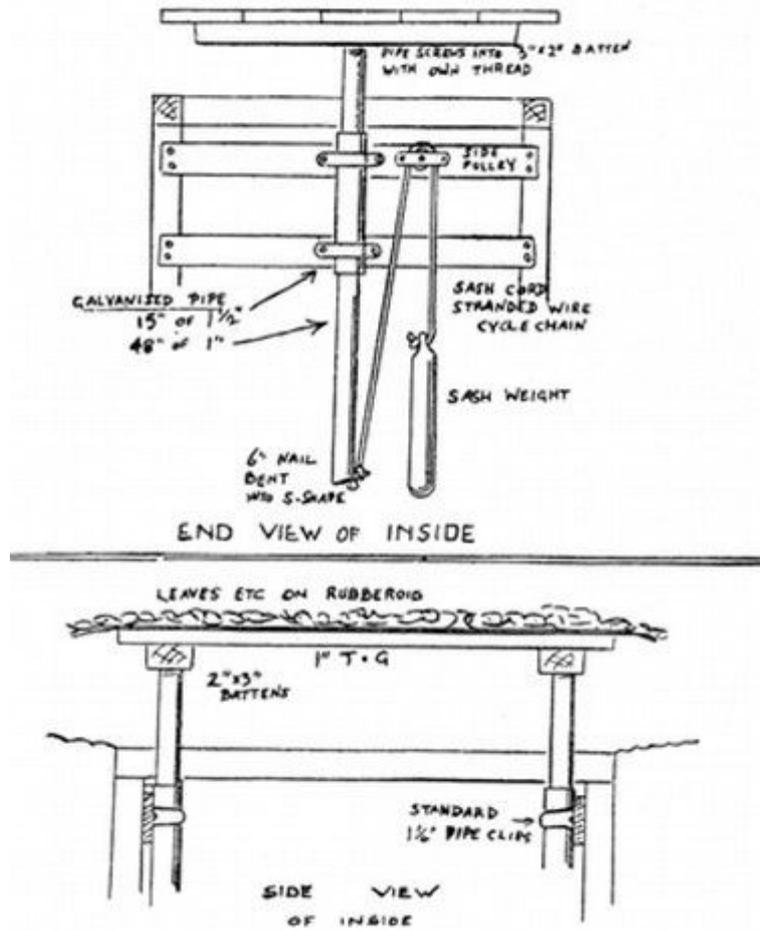
# VERTICAL LIFT O.B. DOOR

Figure 2:  
Design  
for one  
type of

concealed hatch and counterweighted lifting mechanism. This plan was provided to men who attended a training course at Coleshill House. The demonstration model for this mechanism was excavated at Coleshill House.

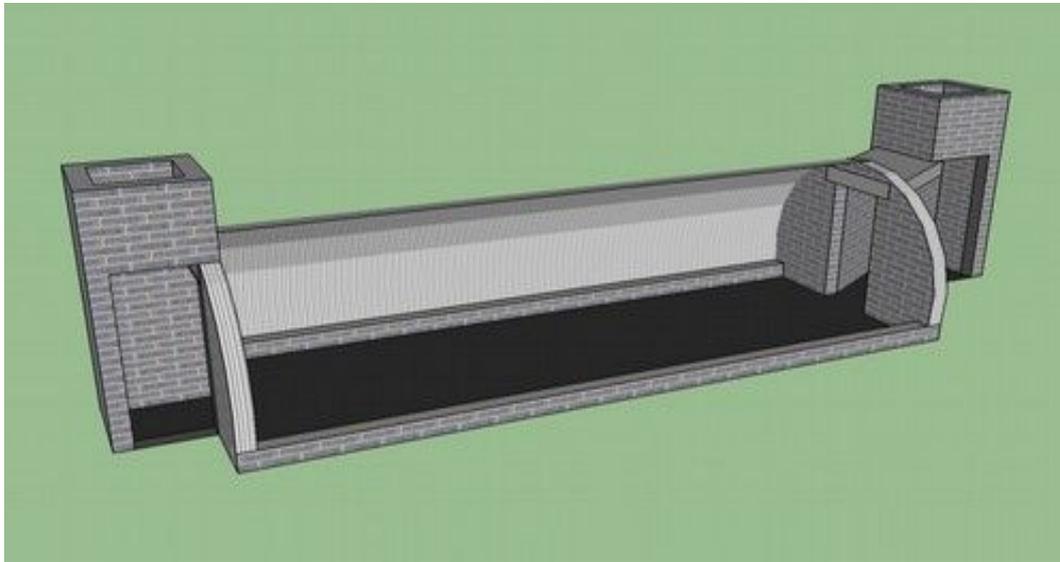
The drawings represent the possible layout of the OB as determined from a brief assessment of the currently visible remains, with internal details extrapolated from the design of other similar OBs. The ventilation system has been omitted for clarity. The current soil level of the surrounding woodland is approximately at the level of the top of the shafts.

Cutaway seen from south side

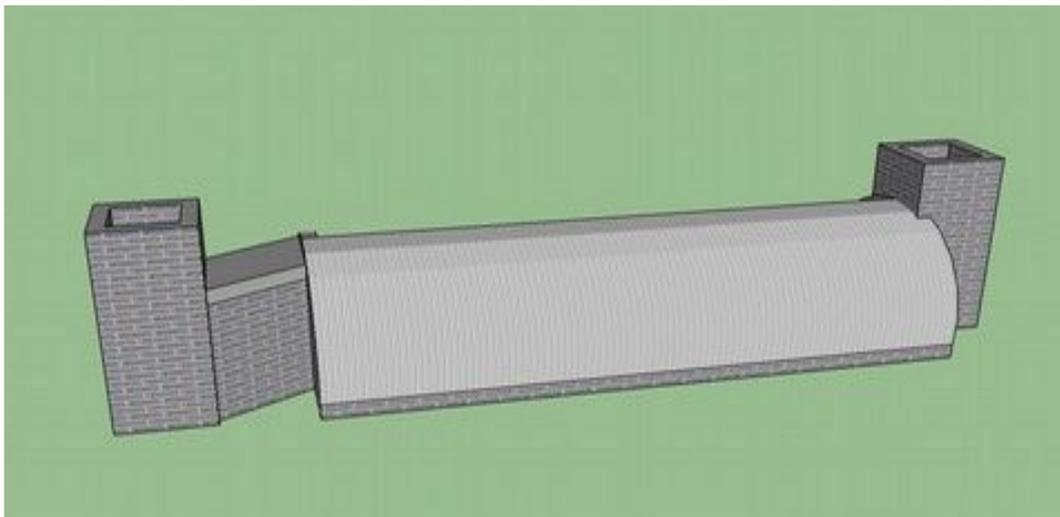
View from north side with main chamber elephant shelter shown intact.
