Date of report: April 2012

# Norwich Zero station Call sign: Bowling Zero

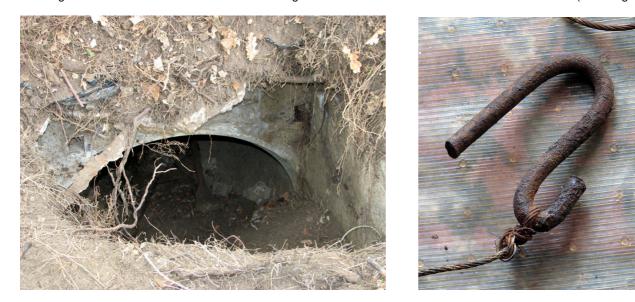
We found three concrete slabs (not original), covered by a layer of about 20 cm of soil laid over a small opening, which we established to have been the exit opening. The original cover (described to us by Mr G) was made from rough concrete and has since deteriorated. Only its rubble remains. Underneath, we saw the top half of a concrete culvert pipe into which soil and some concrete rubble had trickled over time below left). Originally there used to be a manhole-like space with cement walls in front of the tunnel, with a few steps leading down to it (described to us by Mr G). In the concrete lip surrounding the top of the manhole there are several small rectangular spaces which once would have carried a wooden frame and the original hatch. Years ago Mr G had found a steel hook tied to a length of twisted steel wire at the bottom of the manhole (below right).

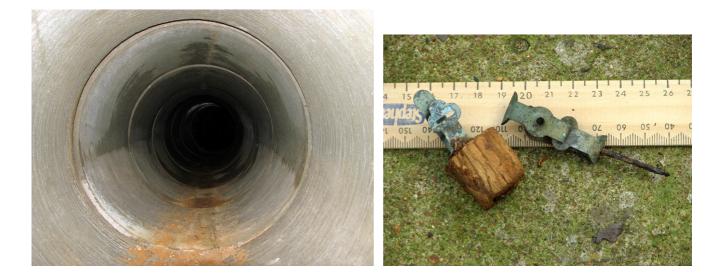
The tunnel is 17 metres long. It was constructed by aligning 18 segments of concrete culvert pipe, each measuring about 90 centimetres (diameter and length). Two small (5 cm diameter) steel pipes can be seen emerging from the rubble and soil at the bottom of the 'manhole'. These pipes may have formed part of the original entrance hatch or its opening mechanism. The tunnel leads steadily downwards, curving in south-westerly direction about halfway down. The concrete pipes have an exterior lining of sheet metal, presumably to keep out dampness. This lining can be seen in the gaps created by the curve of the tunnel.

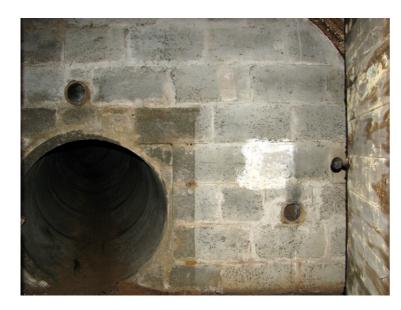
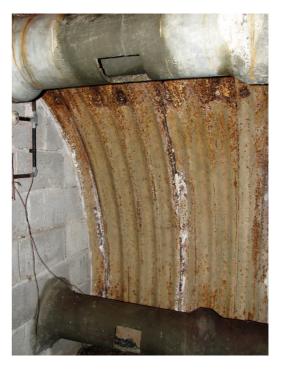
The room immediately adjoining the tunnel is the generator room - it adjoins the radio room in the north. Looking towards the tunnel opening, a different hue in the surrounding breezeblock wall can clearly be discerned. This indicates that the tunnel entrance was covered up. Some of the screws this cover was affixed to are still in place, embedded in the surrounding breezeblocks. Of the cover itself there is no trace. In all likelihood this room would have been used for housing a small generator and for storing the batteries powering the lighting and also the lead acid batteries required for running the TRD radio sets, as well as for the re-charging of batteries.

Two glazed ceramic pipes emerge from the end wall. One of these is to the right of the tunnel opening. The wall just above it is soot-stained and we think that this was where the generator stood, and that the pipe served to extract the generator exhaust fumes. A slightly larger pipe of similar type emerges from the same wall, centred above the tunnel entrance. This appears to be a ventilation pipe. At least one of these two pipes follows the course of the tunnel as it can be seen through a gap by the exit opening.

A sand-filled fuel container with an improvised wooden handle stands next to the wall opposite the two concrete ventilation pipes, just outside the entrance doorway into the radio room. The floor in this room is concrete.

On the left hand side (looking at the exit tunnel) the generator room is traversed by two large concrete ventilation pipes, one near the bottom and one near the roof (avove right). Both of these pipes have a small rectangular cut-out which provided ventilation. The joint of the bottom pipe is supported by a piece of breezeblock. At the bottom of the lower pipe, right next to the tunnel opening, the batteries termination board is still in place, albeit with all wires cut. Two lengths of power cable are still attached to it. The ends of this cable were stripped and pulled apart and they were in all likelihood clipped onto lead acid batteries that needed recharging. The two cables are of the same type as the power cable found by Mr G. This cable does not appear to run into the conduit above, indicating that it came in from somewhere else and ended here. What appears to be either a connecting block or a small fuse box is affixed to this panel. A second switchboard, connected with the termination board, is affixed to the opposite wall just below the top ventilation board and a pair of light fittings is on the wall slightly above it. Interestingly, the outline of this section of conduit and of the two light fittings can be seen outlined in red chalk on the wall. The main conduit continues through the wall into the radio room.

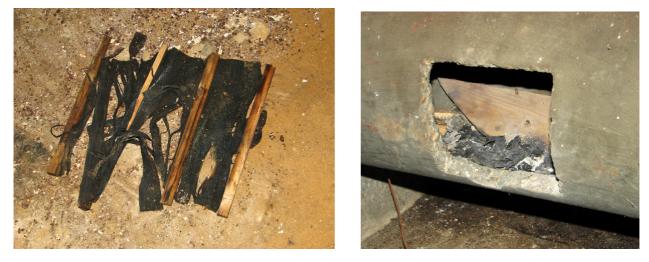
A small black-out screen (below left), measuring about 0.30 x 0.50 cm, is lying on the floor beside the tunnel opening. The black-out fabric is attached to four strips of wood. A small pile of ash that appears to have originated from burnt paper can be seen through the rectangular cut-out in the bottom ventilation pipe. Within this pipe there also is a short (0.50 cm approx) wooden board (a shelf?) with one straight and one rounded edge (below right). A similar shaped board is lying on the floor of the room that adjoins the entrance shaft.

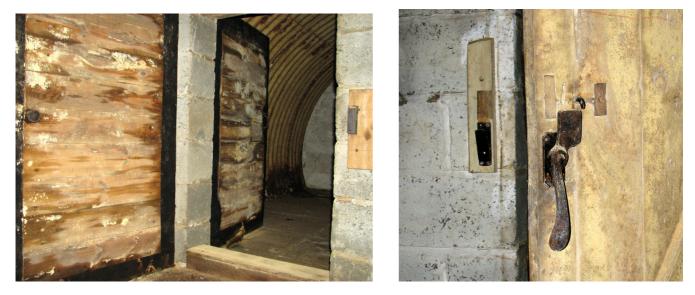
From the generator room, the radio room was accessed through twin doors - two sturdy wooden doors, separated by a raised step. These doors are intact and complete, including handles and catches (mechanism seized due to corrosion). Both doors have some thick black textile fabric, appearing to have been soaked in oil, affixed all the way around their outer edges. We believe that the fabric - it is the same used to stop light penetrating outside through the entrance door, here served the purpose of sealing the twin doors so generator exhaust fumes could not penetrate into the radio room. There two thumb-sized holes at one end of the door lintel. What purpose they served we do no know.

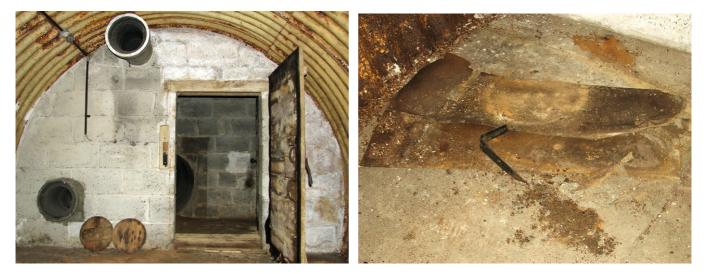
The two aforementioned concrete ventilation pipes traversing the generator room emerge in the radio room, to the left of the twin doors (viewed from the entrance doorway). Their homemade plugs (used for noise reduction) are in situ. In the radio room

the cable conduit runs all the way along the roof, terminating at a switchboard on the opposite wall, beside the entrance doorway.

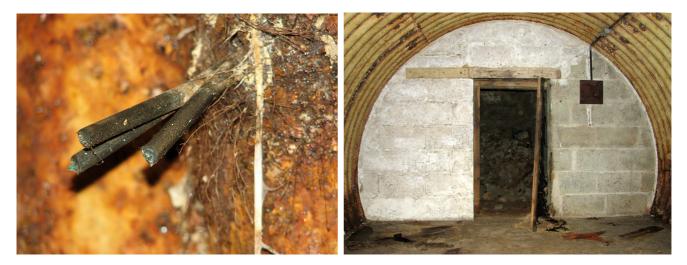
The floor of the radio room was originally covered with a layer of brown linoleum, small sections are still in place (above right) and some of these bear indents of objects that stood on them. Three aerial feeder cables emerge at about 40 cm above floor level near the right-hand corner, near the entrance doorway (below left). The presence of three feeder cables indicates that three aerials – each one on its own tree – were used. The table for the radio sets would have stood near this corner.

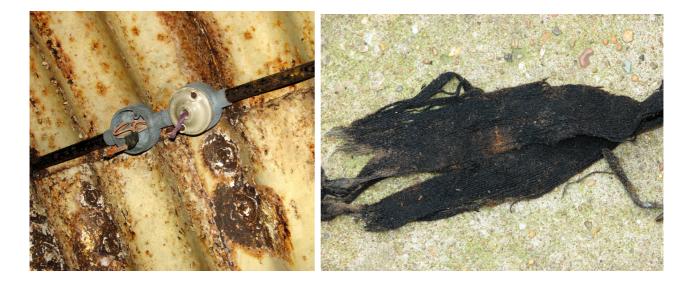
The interior (radio room) side of the wooden entrance door was covered entirely with a sticky black textile fabric, large sections of which are still in place albeit in shreds (above right and below right). This door leads into another small room which still houses a 50-gallon water tank, covered with a piece of sheet metal. The tank is <sup>3</sup>/<sub>4</sub> full of water. Beside it there are two old fuel containers filled with sand. They have improvised wooden handles and served as fire buckets. Water tank and fire buckets stand near the wall on the left-hand side (viewed from the entrance shaft).

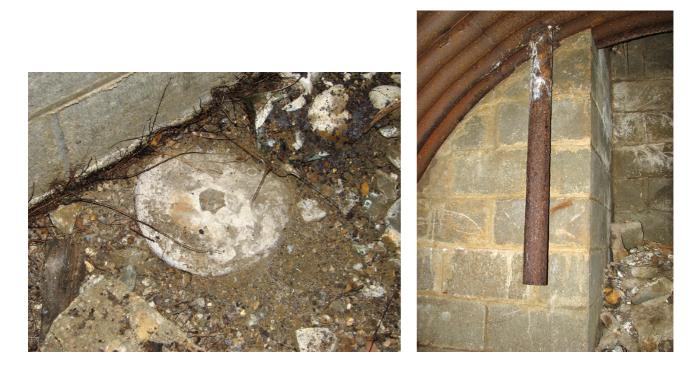
Looking out of the entrance doorway and across the small room adjoining the radio room in the south there is a drop-down entrance shaft which faces the doorway. A large heap of concrete rubble has accumulated at its bottom. Presumably this rubble was created when the top of the entrance shaft was demolished and the opening sealed up. Running down the wall to the left of the entrance shaft (seen from the radio room) there is a cast iron pipe (above right) which ends about 50 cm above floor level. Informants and runners would have dropped their messages, concealed in tennis balls, through this pipe, to be forwarded to headquarters by the radio operations.

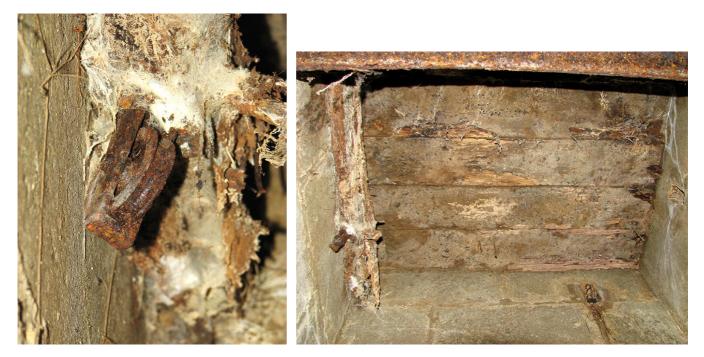
Viewed from below, the entrance opening is covered over with wooden boards. We were unable to determine what lies on top of the boards as in fact the exact location of the entrance opening could not be determined from above. Almost at the top of the breezeblock wall there are several small rectangular depressions. They held the wooden frame that surrounded the opening and probably the entrance hatch. A small pulley (above left) can be seen on one side, still adhering to a section of badly deteriorated frame. Another pulley, embedded in a piece of rotted wood, lies amongst the rubble below. The pulleys were part of the opening mechanism that operated the concealed hatch which presumably was hidden underneath an earth-filled tray.

Coming down the entrance shaft, the uninitiated would have found themselves in a small room that appeared to be in use for storage, with a small water tank standing against the wall on one side. They would not have seen the doorway leading into the radio room because this was hidden behind what looks like a bookcase or storage shelves (below left). When the radio staton was in use, these shelves would have held tins and other paraphernalia and perhaps a few boxes of ammunition. The 'bookcase' consists of a frame extending to both sides of the doorframe and also above the door to a height of 1.65m. The wooden brackets which would have supported the removable shelves are still in place and the door itself has small cutouts so that the shelves fitted partially into it, perfectly concealing both the door and the door frame. The three removable shelf boards are missing but the 'bookcase' is in situ.

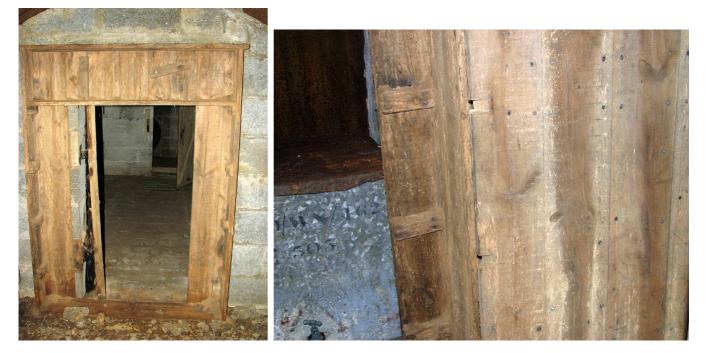
The section of the bookcase above the door has two lengths of wood affixed to the panels covering the wall. These lengths of wood, one towards each side, appear to be fixed by two screws, one at each end. The one on the right hand side, however, is held by only the top screw. The bottom screw is a dummy. This piece can be moved sideways and in doing so it reveals a small carved out space with a drilled hole in it (below right). The hole is just large enough to allow for a piece of string to pass through. The door catch could be released by pulling the string, and the radio room could then be entered by swinging the door

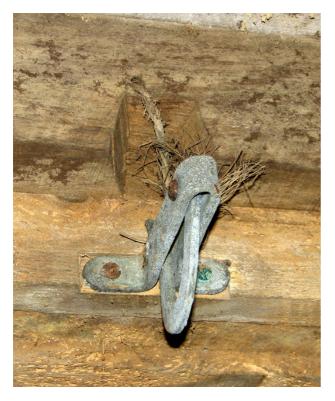
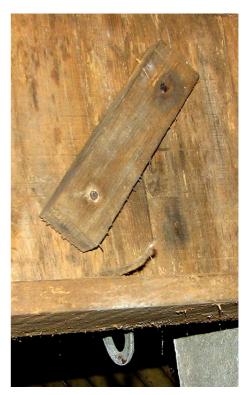
forwards but not without first removing at least some of the shelves. The string is still tied to the catch (in the radio room) and can be seen running through the small hole. It has deteriorated and is missing on the other side from where it would have been pulled (below left).

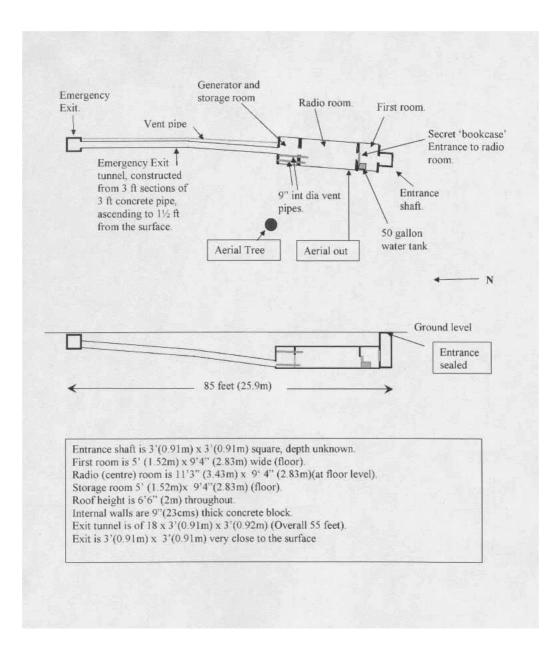
#### 2) Plan drawing of Zero station view from above and from one side

Overall length from entrance to exit incl tunnel: 85ft = 26 metres Thickness of end walls: 23 cm/ 9in. Material: breezeblocks Roof height: 2.10m (6ft 10 inches) Entrance shaft: 0.90 x 0.90m / 3 x 3ft - 2.80 m (9ft) high from floor to covering boards Dimensions of small entrance room: 1.50 x 2.85m (5 ft x 9ft 4inches) on floor. Concrete floor Water tank: 0.76 wide x 0.55 x 0.55m - 3/4 quarters full of water - sheet metal cover- tap in working order Entrance door: 1.35 x 0.81m - doorstep 4 cm high. Back blacked-out Bookcase: 17 (outer frame) x 24 x 14 (inner frame) cm deep Shelf: 14 deep x 1.24 long, 3 cm thick board. Height: 1.65m Dimensions of board that conceals door catch mechanism: 22.5 x 5 x 3 cm Radio room: 3.50 x 2.85m (11ft 3inches x 9ft 4inches) on floor Large vent pipes: concrete: both 23 cm (9 in) internal diameter Floor in radio room: Concrete, covered with linoleum. Exit doorways: 1.50 x 0.93 m - doorstep 78 cm wide by 11 cm high. Black-out fabric around edges Generator room: 1.50 x 2.85m (5ft x 9ft 4inches) on floor. Concrete floor 2 small vent pipes, one above tunnel (10 cm), one opposite twin doors (8 cm) - wall above soot-stained Exit tunnel: 18 3-foot sections of concrete pipe, 55 ft long = not quite 17 metres with exterior lining of sheet metal
