Underground in WWII – Halstead In-Station (dugout)

Evelyn Simak and Adrian Pye

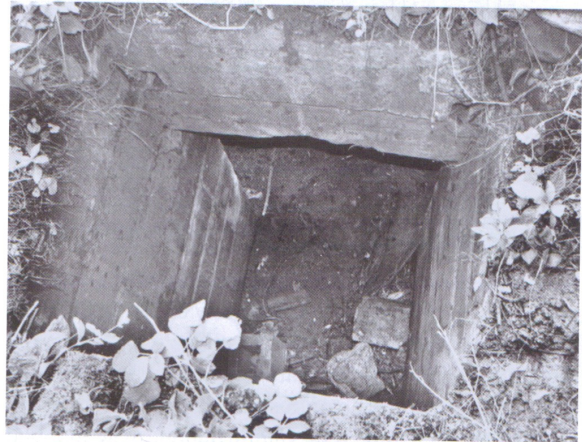
When the station was closed at stand-down, the top row of breeze-blocks and the concrete lip that sealed them from above were knocked off and the broken pieces thrown down the entrance shaft. Several small rectangular recesses can be seen in the breeze-blocks near the entrance opening. They served to support a timber frame to which pulleys for operating the opening mechanism would have been attached. The floor below is littered with broken sections of timber framing, some bearing the imprints of pulleys that appear to have been knocked out.

The exterior of the hatch would have been well camouflaged so as to blend in perfectly with its surroundings, and casual passers-by would have been unable to spot it. A ladder would seem to have been necessary for access, as there is no trace of the presence of built-in steel rungs.

View down the entrance shaft

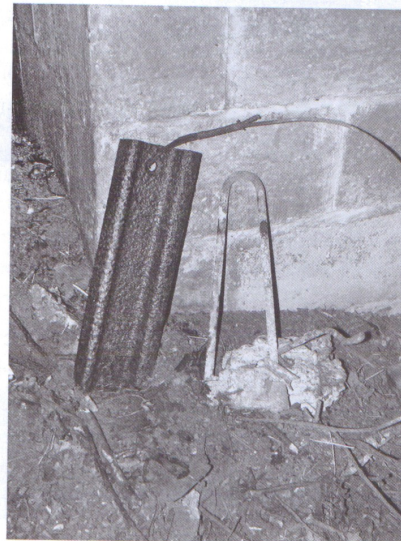
The counterweight – a length of 95 lb bullhead railway line – was found at the bottom of the shaft, which leads directly into a small anteroom or lobby that in all probability would once have contained a water tank and a chemical (Elsan) toilet. Coming down the shaft, the uninitiated would have found themselves in a small room that to all intents and purposes was used for storage, containing shelves stacked with boxes and tins. This shelf unit, however, was cleverly designed to conceal a door leading into the operations room. A cast-iron pipe, the remains of which are still in place, ventilated this lobby.

The counterweight – a length of 95 lb bullhead railway

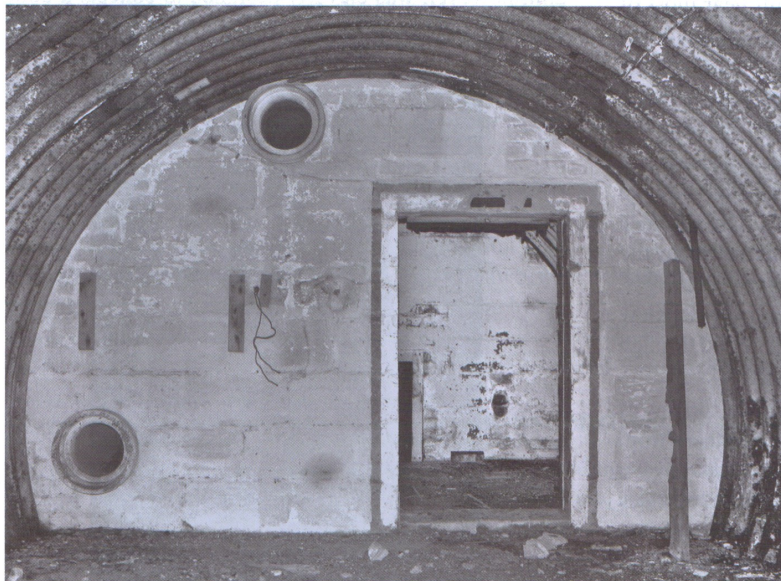
The operations room, whose interior walls are painted an off-white colour, was accessed through the secret door in the lobby. Its floor is covered with precisely laid concrete paving slabs which were originally covered by a layer of brown linoleum (some still in situ). In several places the corrugated iron of the elephant shelter is badly corroded and has fallen away, particularly along the

bottom where it meets the floor. Consequently, sandy soil is trickling into the chamber, partially covering the floor and any small artefacts that might still be lying there. The openings of two large ventilation pipes can be seen in the wall separating the operations and the generator room. Ventilation in all known In-Station dugouts was supplied in the same way, i.e. by two large concrete pipes, the lower being the inlet, the upper the outlet pipe. Fresh air entered the dugout through the bottom pipe, expanding and rising as it warmed until it reached the top pipe, from where it would have made its way outwards, being replaced by fresh air. This process could, if necessary, be assisted by a fan or by the use of a Tilley lamp (N. Oxenden, *Auxiliary Units – History and Achievements, 1940–1944*, p26).

The operations room
(view towards the generator room and emergency exit)

‘1A’ can be seen pencilled on the wall beside the outlet pipe and ‘1B’ was written beside the inlet pipe. Obviously, the annotations meant something, but what exactly remains a mystery. Presumably there would originally have been some kind of covers, perhaps wooden blanks, used for covering the ventilation pipe openings for the purpose of noise reduction and also to prevent generator exhaust fumes from seeping into the operations room. Pencilled

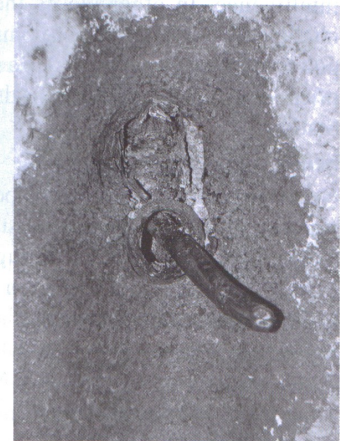
One of two two-cored 240 Volt mains power cables

Two two-cored 240-Volt mains-power cables entered the operations room through the opposite wall, each one contained within its own ducting.

Even when used for heating only, the load would almost certainly have been too high for a single cable to carry, and it is for this reason that two cables were used. As no lighting conduits or cables have survived at Halstead it is not possible to establish whether the dugout had two separate lighting circuits, as has been documented elsewhere.

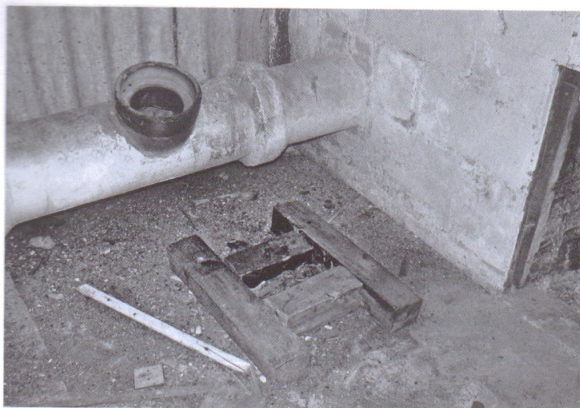
On the floor of the Generator room, the wooden generator-mounting block is still in place, in its original position. Constructed from sections of 4-inch-square timber, this is the only original specimen known to have survived. Four six-inch metal bolts on its underside, one near each corner, not only prevented it from being propelled all over the smooth paved floor by the generator's vibrations when it was running but also held it firmly in place when pulling the starter cord. The bolts, albeit quite corroded, are still contained within the holes that were drilled into the paving slab that the block is resting on. This disproves earlier theories as to whether generators may have been positioned on shelves or benches.

Wooden generator block

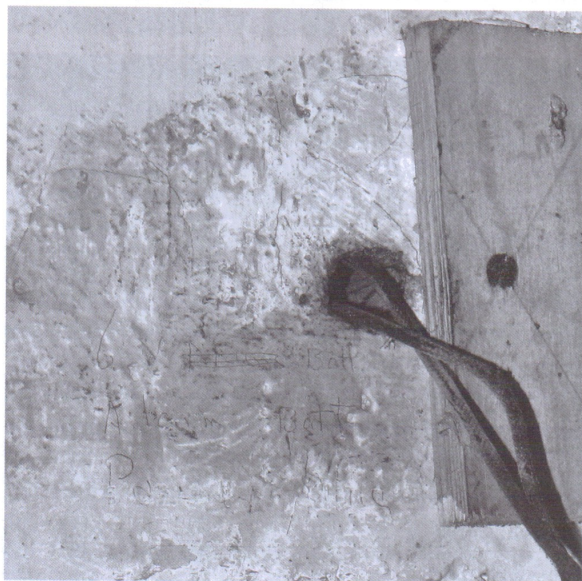
The generator room is of particular interest not only because of the unusual ventilation pipes and the original artefacts still in situ but also in that a number of handwritten annotations can still clearly be read. '2A' can be seen written on the joint of the outlet pipe. On a small patch on the partitioning wall between wireless and generator room, immediately beside the spot where two wires, covered with woven fabric, are fed into the adjoining wireless room through a hole in the wall, there are annotations referring to: '6V Batt'(eries), 'Alarm Batt'(eries) and 'Power Plug' (below).

A broken wooden panel was found on the floor of the generator room. This panel would originally have been affixed to the wall with four screws. It has a number of drilled holes through which cables would once have been threaded. Note the pencilled annotation 'Fan and 6V Lighting'. The cable clip seen below the drilled holes presumably held the fan's wire in place. The pencilled annotation 'Power' is yet more evidence of the station having been connected to mains power.

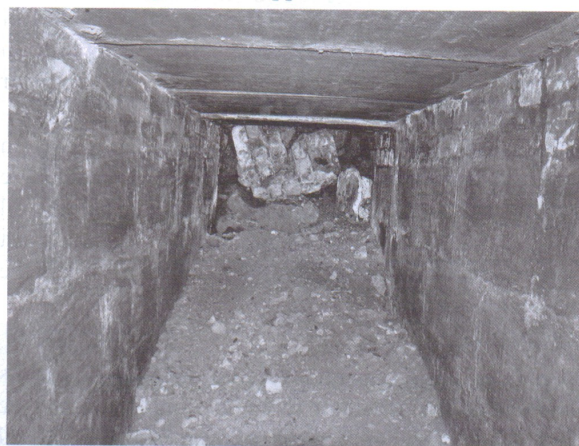
escape tunnel which at Halstead In-Station is an unusually short passage of about ten feet in length, before it is cut short by the slope of the earthen bank it was built into. The opening has retained most of its original timber frame but nothing remains of the cover that would once have sealed it. The passage has a concrete floor, covered with soil and debris.

The walls were constructed from breeze-blocks, with some brickwork filling gaps mainly along the top, and the roof was made from concrete paving slabs. The steep slope the exit opening emerges onto is today heavily overgrown with brambles, making it currently inaccessible. An interior view suggests that the exit opening appears to have been destroyed and/or backfilled. As the true length of the tunnel could not be ascertained due to the collapse it is possible that it may have been somewhat longer than it appears.

Emergency exit tunnel
