Excavation of an Operational Base at the former grounds of Melville House, Fife.

Rathmell Archaeology Limited (RAL) and Coleshill Auxiliary Research Team (CART) during the archaeological mitigation of the Auxiliary Units Operational Base at Approach Wood, Mountcastle Quarry, Fife. Situated in the former grounds of Melville House. 11<sup>th</sup> – 20<sup>th</sup> October 2022

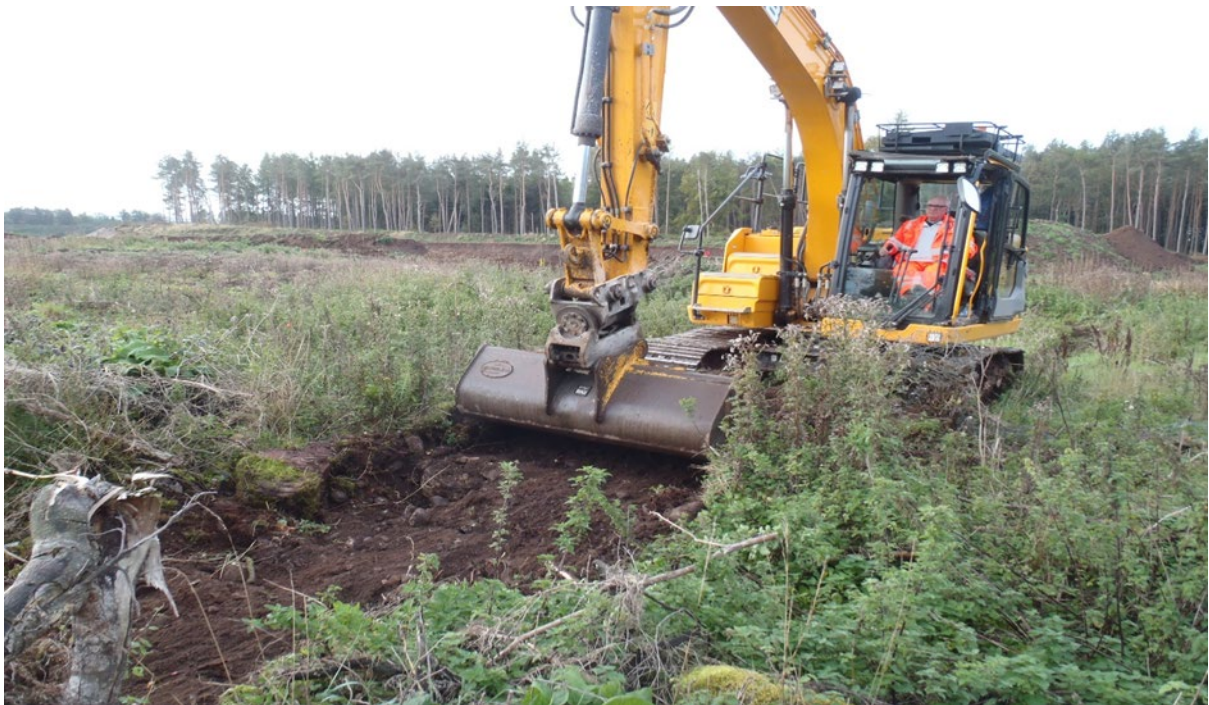
Image © David Blair

Most of the first two full days were taken up with clearance work, removing the top layer of vegetation.

As can be seen in the image below.

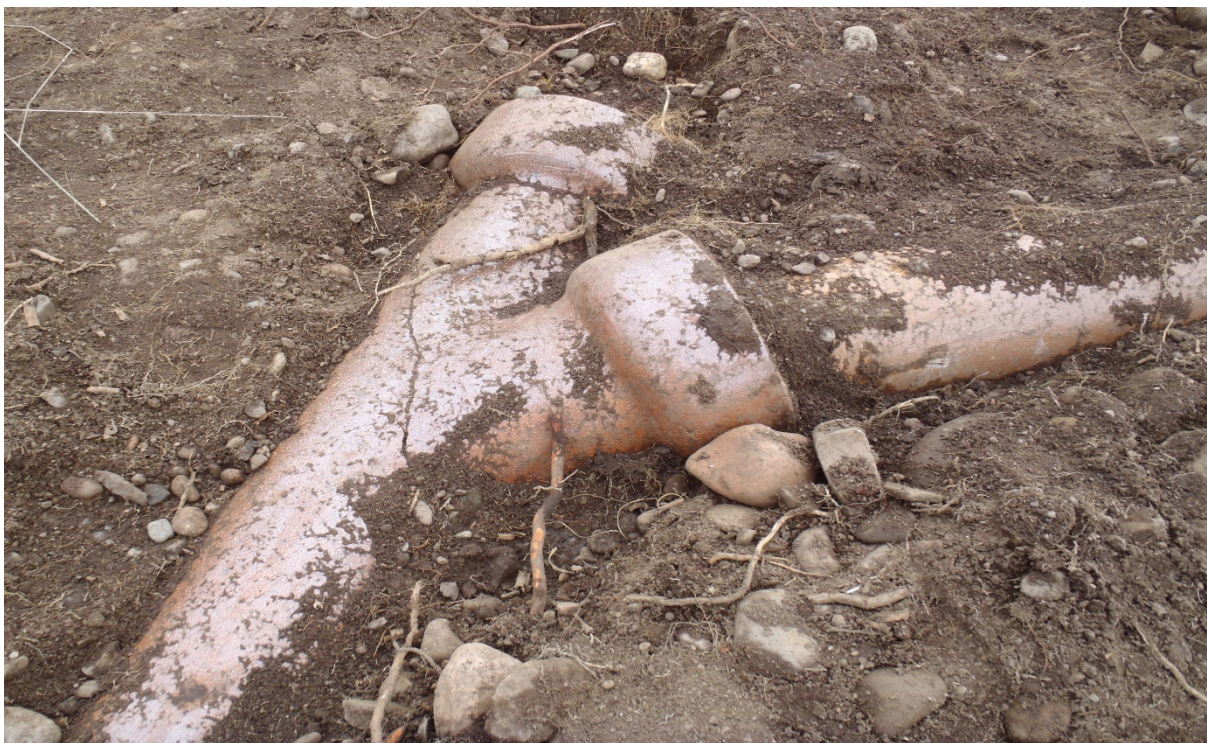
But finds were soon emerging as in this image, exposing some of the ventilation pipes. © David Blair

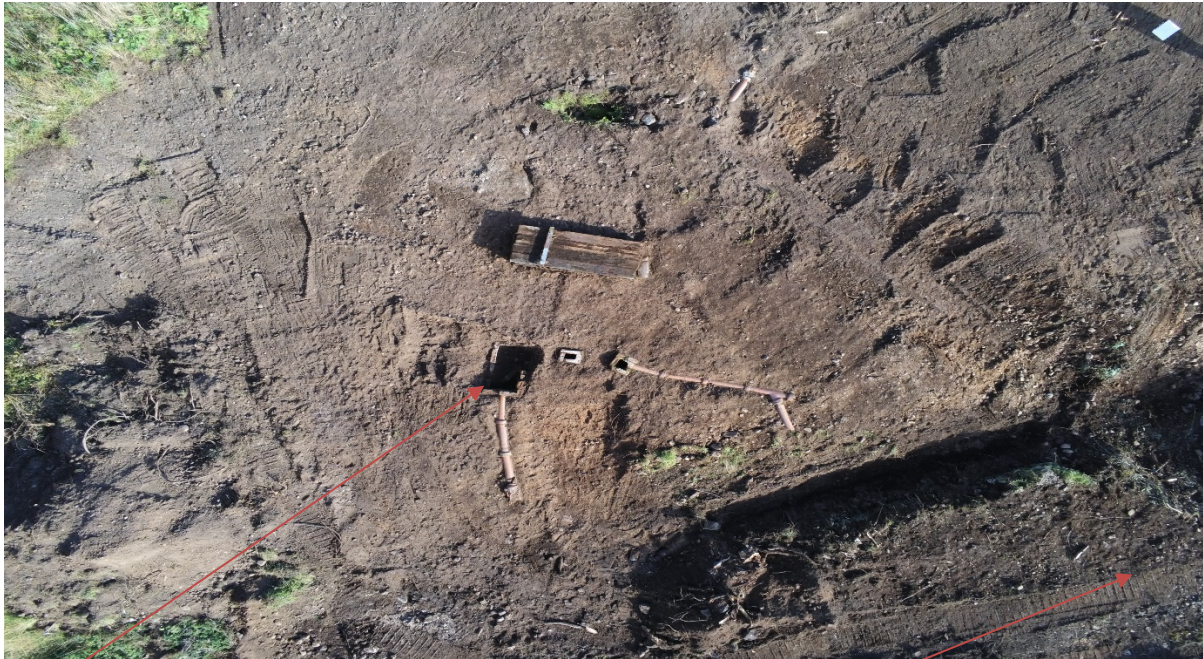
Image © Liam McKinstry [RAL]

Drone view of the site once cleared. In evidence are the Ventilation pipes. North lies to the left of image. Centre of image is the rail sleepers covering a hole in the roof of the OB, which was installed post war.

*Of note is what would have been the entrance hatch into the OB. Ha-Ha remnants to right of image*

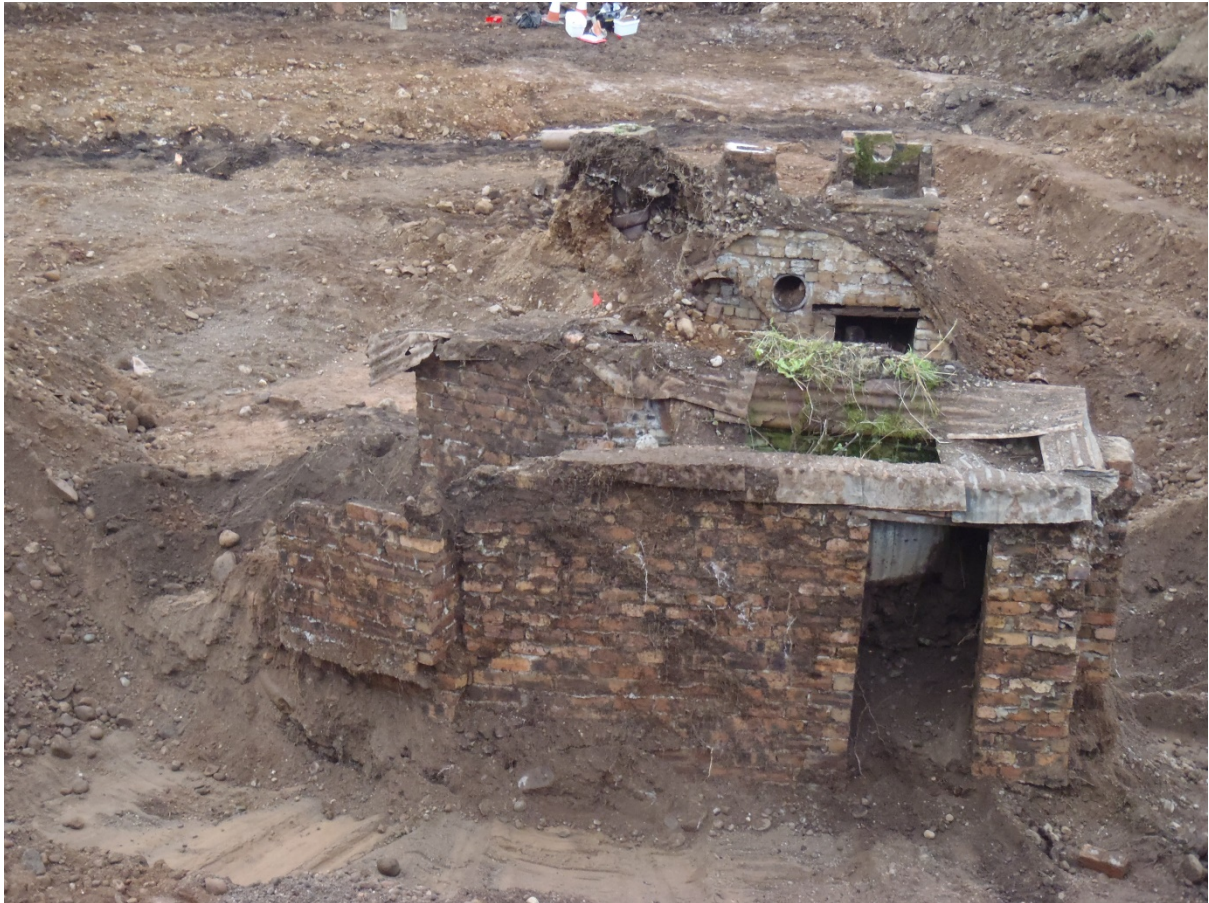
Image © David Blair

One oddity was in evidence, there was a door...to nowhere... 'see image below.'

Door that seemingly led to nowhere. Nothing found on this side to indicate there was another structure to which this door led to, nor was there any door hinges or other features on the brickwork. The corrugate iron coverings seen in this image, seem to indicate they are post war. Possibly to stop anyone entering into it when in 1950 Melville House was used as Dalhousie Preparatory School for boys. [1950-1970]

To the left of the image is the double wall leading into a ditch/tunnel and then out onto the Ha-Ha which is indicated by the black line at the top of this image.

The ditch didn't have any signs of being a continuation of the brick built double wall, no signs of anything that I have found in other OB's to indicate an enclosed, covered escape tunnel.

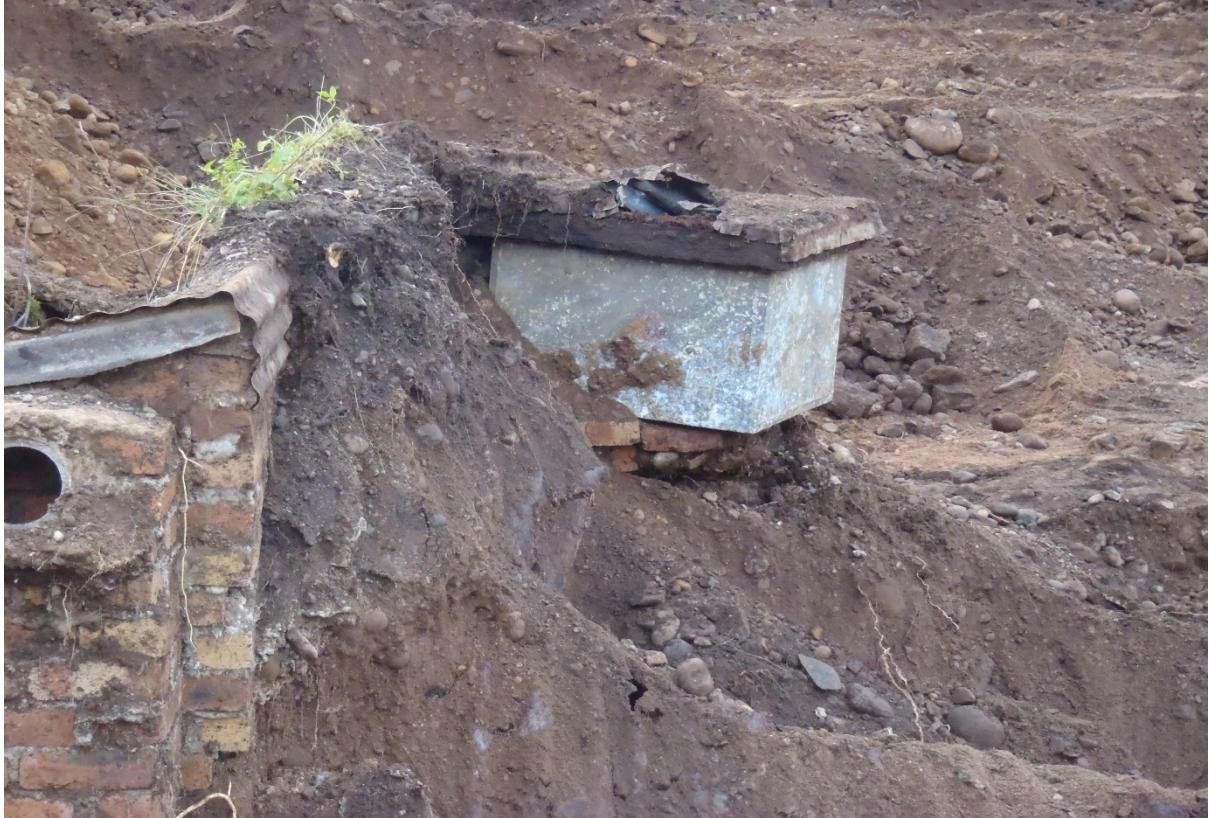
Image © David Blair

On the other side of this wall, we found a 100 Gallon galvanised water tank. I know this as it was stencilled on the tank. This water tank was on the outside of the OB, another feature I have never seen in any other OB I have been in.

Galvanised 100 Gallon Water tank.

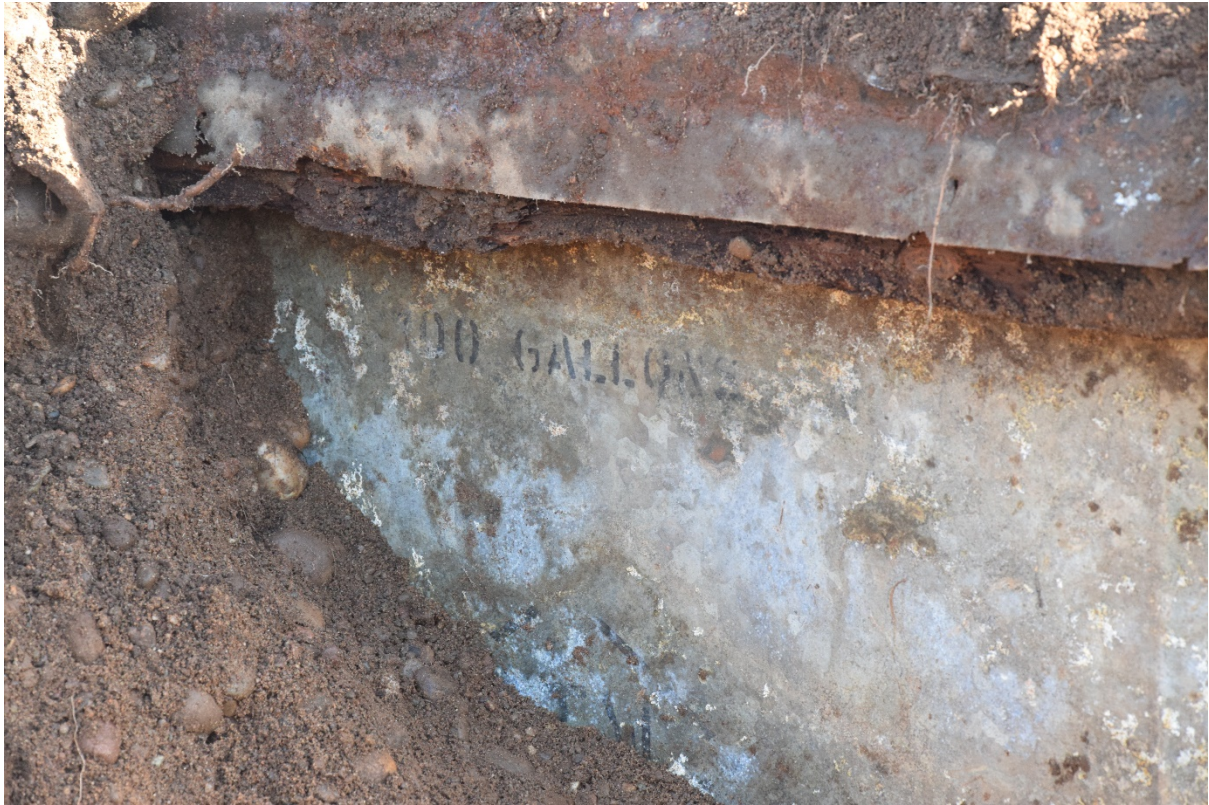
Image © David Blair

The tank sits precariously on bricks with wooden cover, there was a pipe in the top of the tank and another one on the other side of the double wall leading into the water tank. I noticed water was actually dripping out of this pipe.

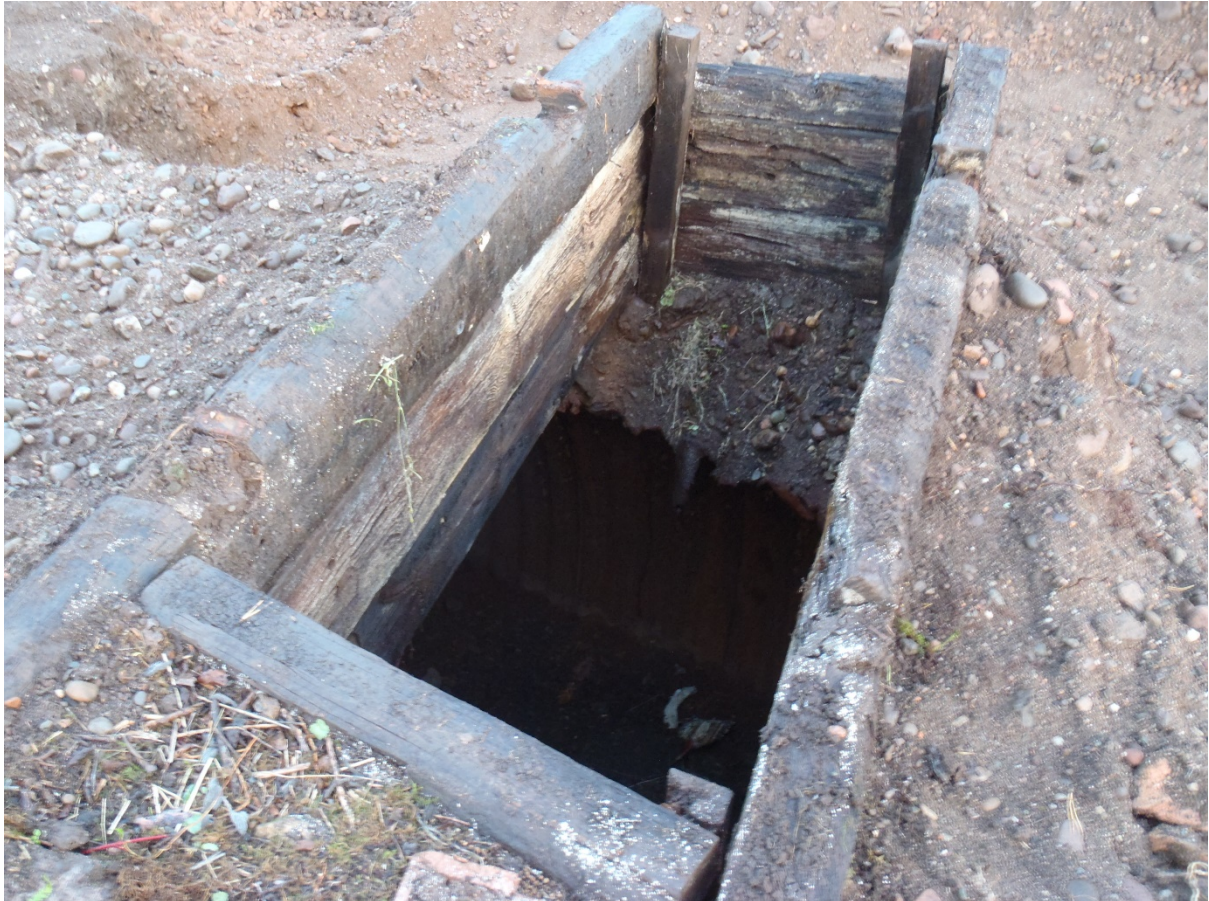
Image © David Blair [CART]

Side wall construction of better quality than at both ends of this OB. Of note is the lack of concrete floor, as seen in this image. This is after the bucket on the JCB had excavated down into what would have been the concrete floor and was by now well below that level, as can be seen by the dark soil emerging. There was an indication that instead of concrete it was a wooden floor, as remnants found rotted away when we excavated into the base of the OB floor.

Also seen at the top of this wall is the outline shape of the Corrugate iron sheeting.

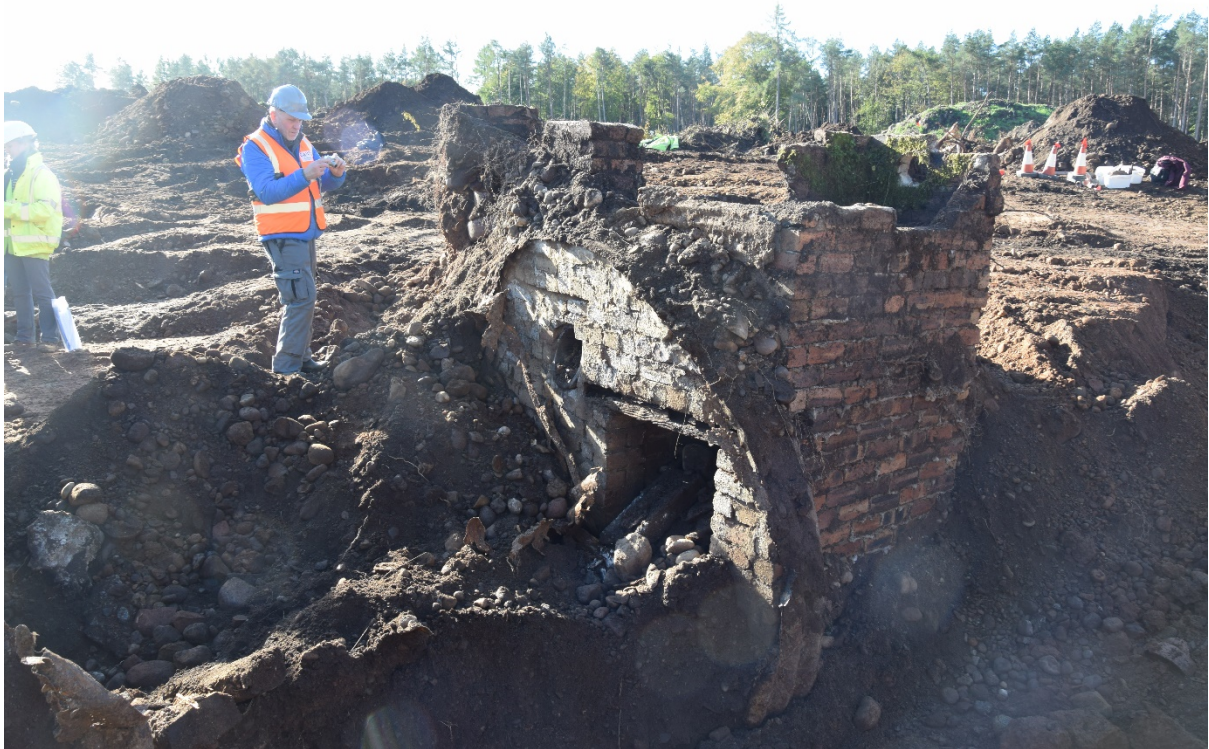
Rail sleepers on which the wooden covering, I found on my first site visit. Inside there were many animal carcasses, mainly sheep, this was verified by our on-site archaeology expert. Story goes that dead sheep were disposed of into this OB. Image prior to roof collapse. Sleepers and posts are post war, probably at the same time as Dalhousie Preparatory school occupied Melville house or other land owner/farmer of the time?

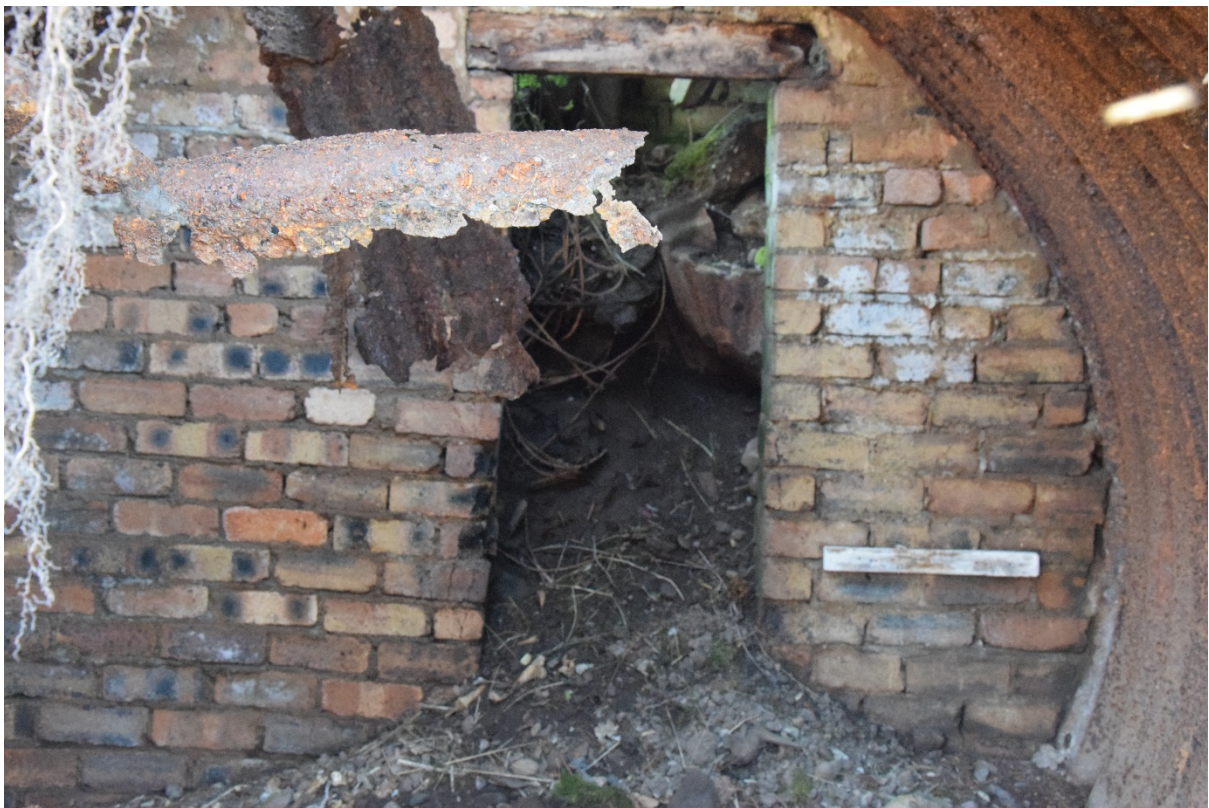
Image © David Blair: Entry/Exit into and out of the OB from this side, under normal situations.

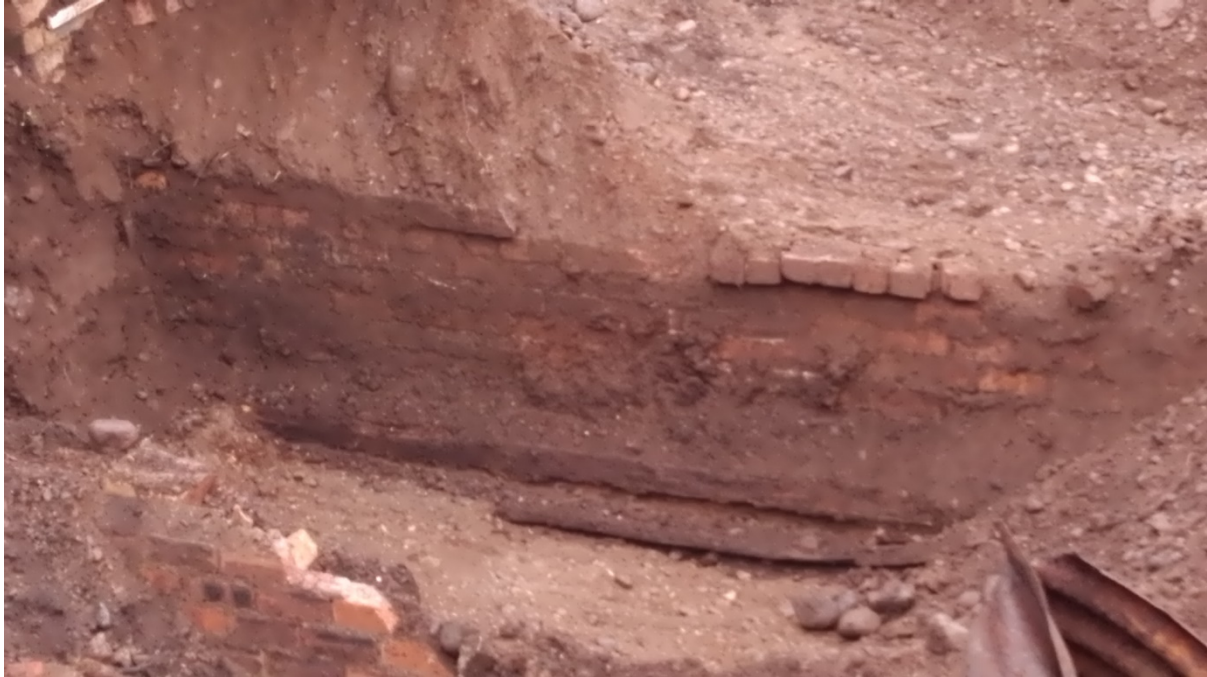
Image © David Blair. Door aperture that leads into the curved double walled escape route, right turn

**Note:** above image. What looks like white paint on the wall to the right, it could just be lime from cement? Also note the wooden strip attached to the wall. The door to nowhere would be through that door and turn immediately left.

An indication, possibly that there was a wooden floor instead of a concrete one.

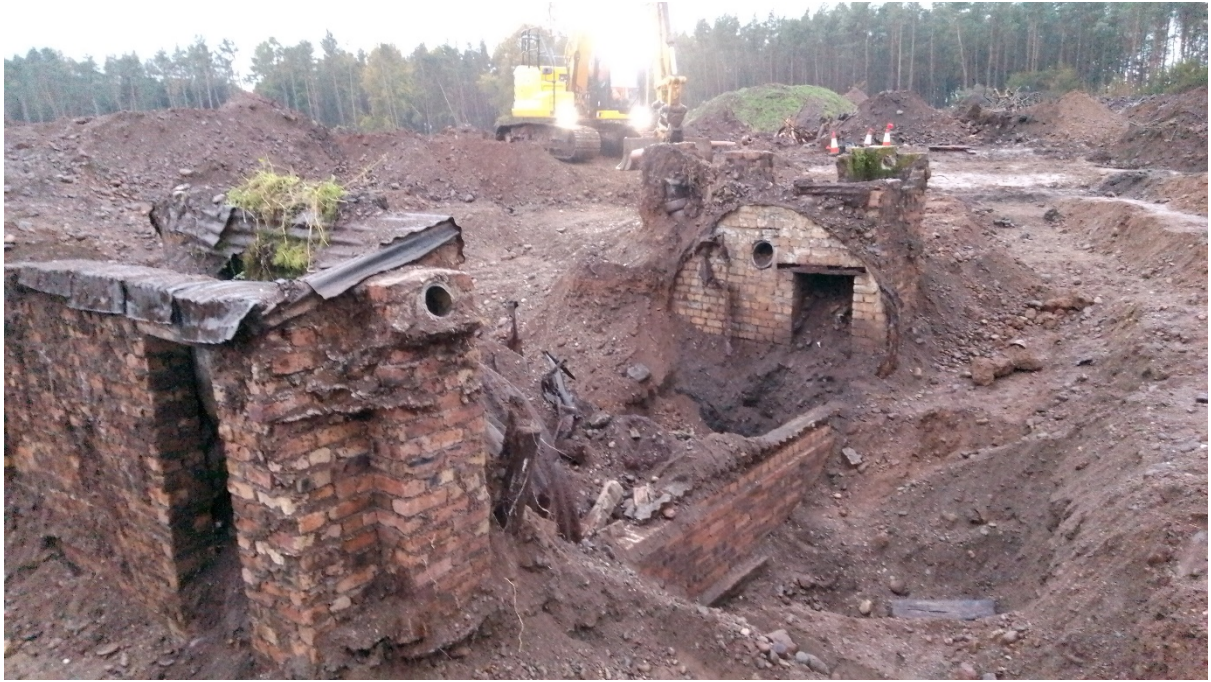
Images © Liam McKinstry [RAL]

The entire OB measures 9.5mtrs from East to West along its length and 4.65mtrs at its width North to South

With the main inner chamber measuring at 6.5mtrs East to West and 3mtrs North to South.

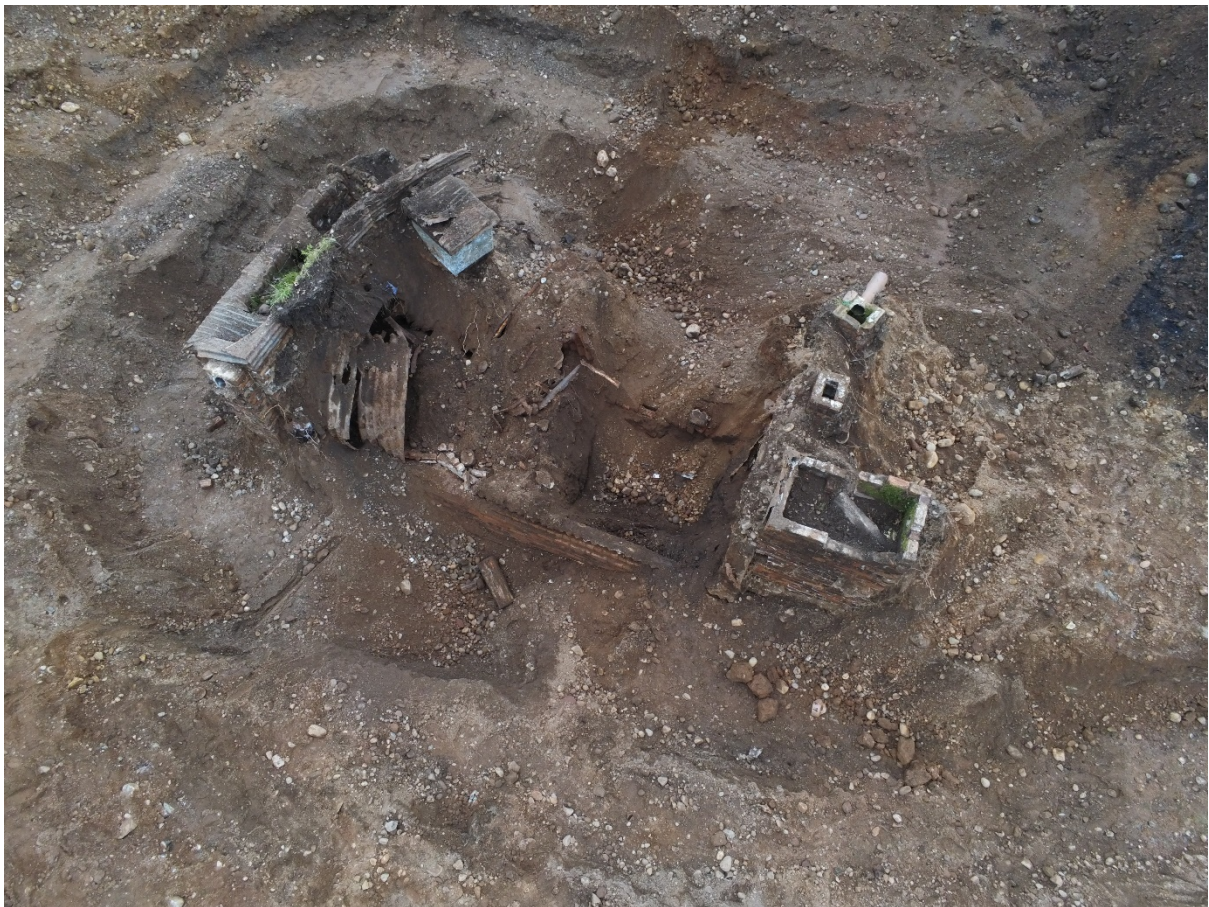
Gives a good idea of the depth at which the OB was excavated to.
